Lucky Escape at Southampton

Clint McCrae, Andy Woods and Paul Mason had a very lucky escape when they hit an overhead cable on the Denizen site in Southampton recently.

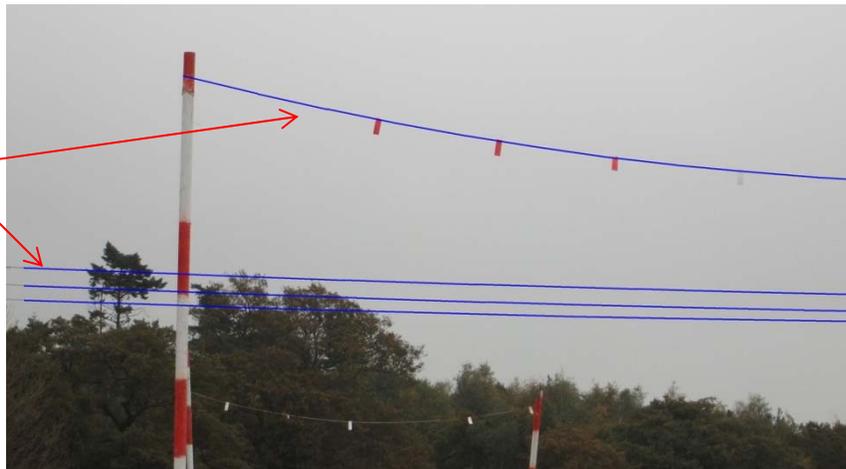
Cable below goal post markers!

The guys were carrying out an excavation between a set of goal post markers that identified the position of the overhead cable, but thought that they would not hit it despite the cable being below the level of the goal posts. Clearly this proved not to be the case and when Paul hit the cable with the excavator both Andy and Clint were extremely lucky not to be killed.

Andrew Brown said after discussing the incident with Clint “ putting guys to work when the cable was below the level of the goal post protection was madness as this was clearly not a safe system of work. Even with the best will in the world, we need to know when to stop before an accident happens and all our employees must be happy to question what they are being asked to do before they do it. Thankfully there was nothing more than loss of power, rather than loss of life.”
